Sebert Trillingstechniek B.V.

Report M13.001-P13.001 rev.01
Date 26 august 2013

Vibration tests on a TNAML Luminaire

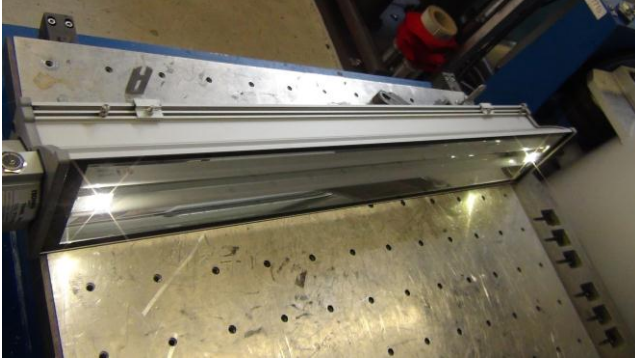
Figure 1: Test item

Type designation	Lighting luminaire
Product number	TNAML 2x36 E
Serial number	T13.00255
Weight	+/- 15 kg
Figure	#1

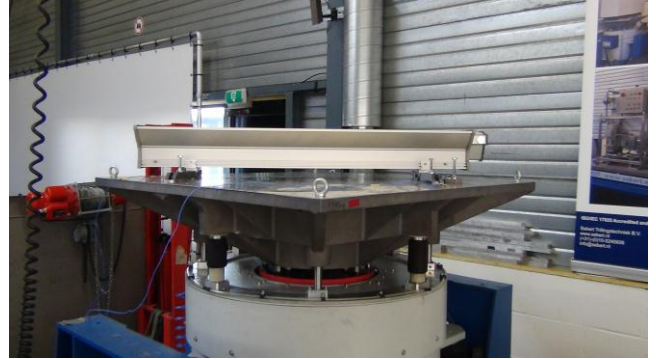
Figure 2: Test setup Z direction

The test item was mounted on the vibration table through its normal points of attachment and in normal orientation with respect to the vertical. The test were carried out in three mutually perpendicular directions, see Figure #2 for de vertical (Z) direction, see Figure #3 for the horizontal longitudinal (Y) direction and see Figure #4 for the horizontal transversal (X) direction.

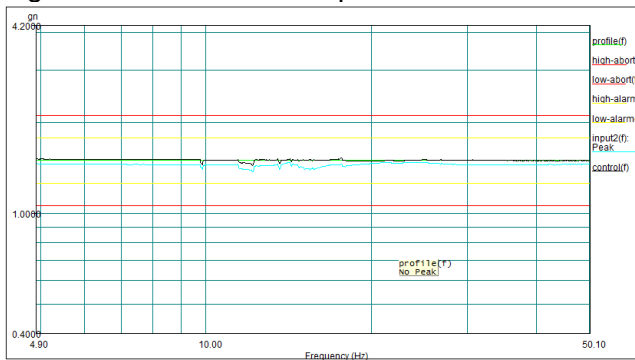
Figure 5: Test A vibration plot

A vibration test in the three mutually perpendicular directions has been carried out, see Table 5 for the summary. See Figure #5 for a typical vibration plot. During the vibration test in Y direction 2 connection bolts came loose see Figure #6, in accordance with Technor Benelux B.V. the bolts have been tightened and further testing continued. No visual damage or functional errors have been found on the test item after the complete test sequence.

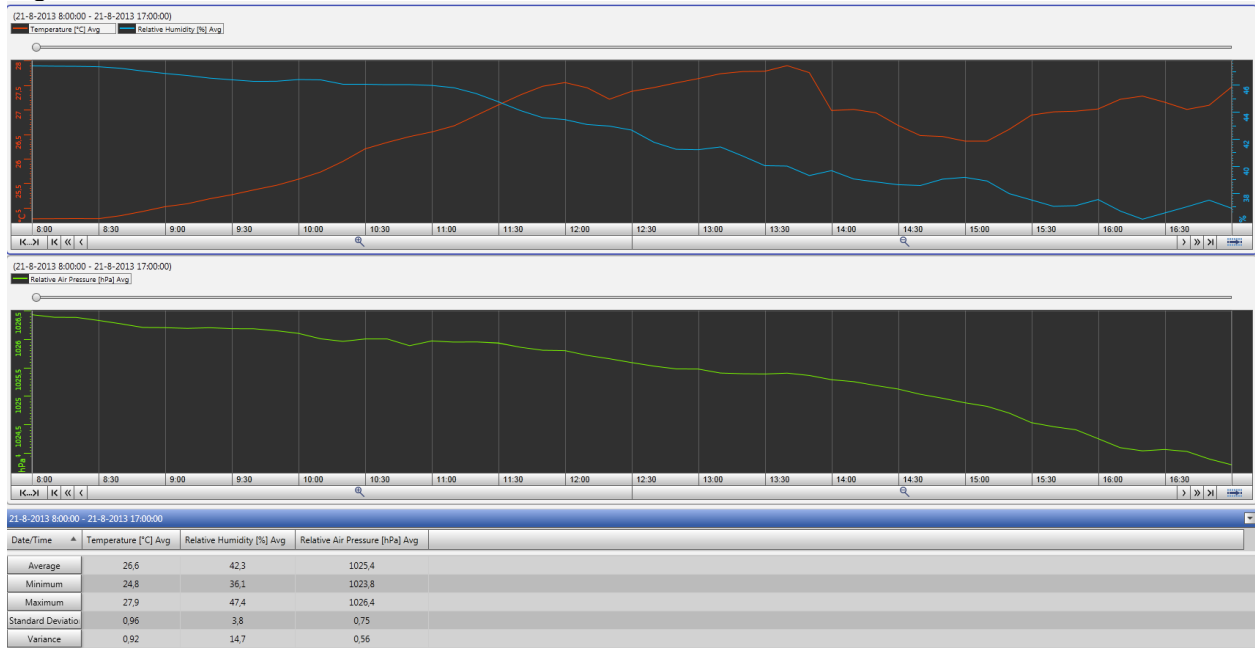
Figure 7: Environmental measurement

See Figure #7 for the environmental measurements during the test sequence.
